Safety Alert

071 – In Service Rope Failure

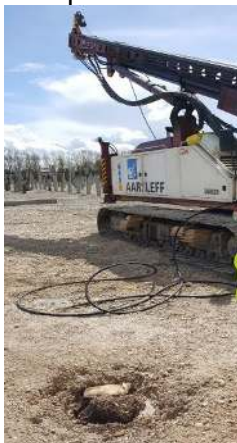
A recent incident occurred where a hammer rope on a driven piling rig failed in-service. The rig was in the process of slewing off a recently installed pile with approx. 3m final projection. As the operator slewed the rope failed without warning and the hammer dropped down the mast approx. 3m to the floor. Luckily no persons were in the vicinity. The Rig Attendant's next task was to replace the under-pack timbers on the machine, thereby putting him in the danger zone had this failure occurred at that point.

Point of impact with the floor

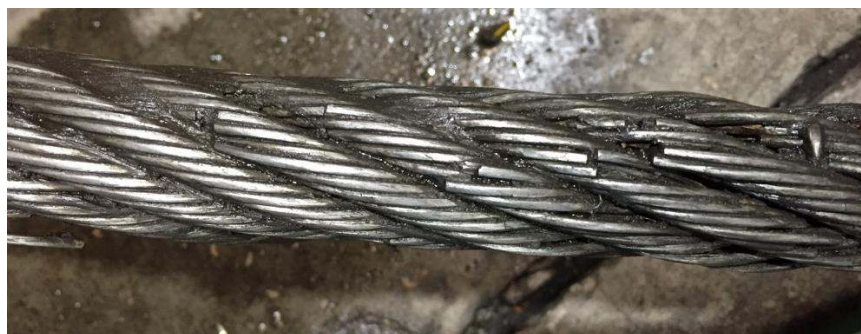
- The rope broke approx. 8m above its anchor point on the rear of the hammer. This section would be subjected to deflection around the cathead and the rear deflector sheaves.

- The crew reported that there were no issues or defects noted prior to the incident.
- The rope and piling rig mast were heavily contaminated in grease making a visual inspection of the rope very difficult.

- An independent report by the rope manufacturer identified a 'high amount of wear with multiple fatigue breaks exceeding the recognised discard criteria' i.e number strand breaks over a give distance.

Cleaned rope showing multiple fatigue breaks

- Routine replacement period of hammer ropes reduced to 12 months.
- Review the management process for maintenance and inspection / replacement of rope systems, including training for relevant persons where necessary.
- Further discussions with our thorough examination competent persons – ongoing.
- ALL 'rig hammer stops' to be used whenever a person is working beneath / close to a free suspended hammer i.e. when not sat over a pile.
- Rig operators to highlight issues with rope contamination from grease which affects visual inspection of ropes. It maybe that we are over greasing in some areas, or grease is not reaching its intended point.
