SAFETY ALERT

Date/Time of Incident:	18/06/2019
Type of Incident:	High Potential Incident
Nature of Incident/Injury:	Fire damage to vehicle during fabrication works

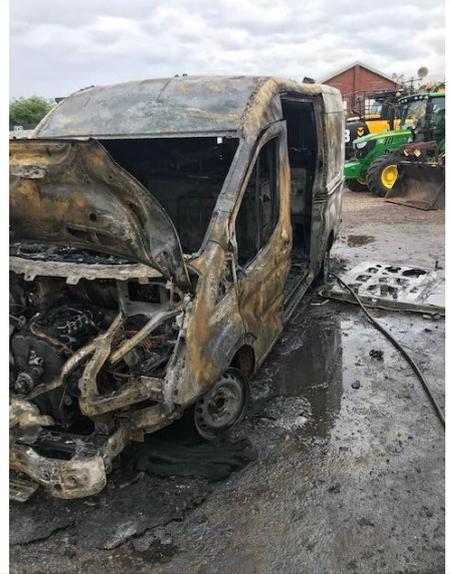
This alert has been produced following a serious incident which occurred whilst a fitter was carrying out fabrication works. The fitter was unharmed however there was the potential for serious injuries to be sustained by him, and anyone else working in the vicinity had the gas bottles exploded.

The fitter was stood at the side of the van adjacent to the doors using Oxy-Fuel burning equipment to heat up a metal bracket.

The hoses were laid through the van and out of the side doors

The fitter turned to see a fire in the van spreading rapidly.

A small leak in the equipment plus the back doors being closed is believed to have caused the build up of gas. The flashback arrestors prevented the flames entering the gas cylinders.

Root cause (if known):	The root cause related to the maintenance and inspection of plant & equipment. The pre-use check carried out by the operator did not identify the small leak.
-------------------------------	---------------------------------------------------------------------------------------------------------------------------------------------------------------

Action Taken: All items of hot works equipment inspected for signs of damage, and leak tests performed, prior to work commencing. Repair / refurbish all gas burning equipment in accordance with the guidance published by the British Compressed Gas Association

Where gas cylinders cannot be removed from the van during use, they must be positioned close to one of the van doors. During use, the van's back and side doors must both be open to ensure through ventilation and prevent gas building up inside. Gas hoses must be run directly out of the van through the nearest door

The work area shall be located clear of the van to prevent heat/sparks reaching the van
Fire extinguishers must be placed outside of the van in your work area
