# Esh Winning

## Drilling and Grouting work to a housing development on an extensively worked coal seam in the North East

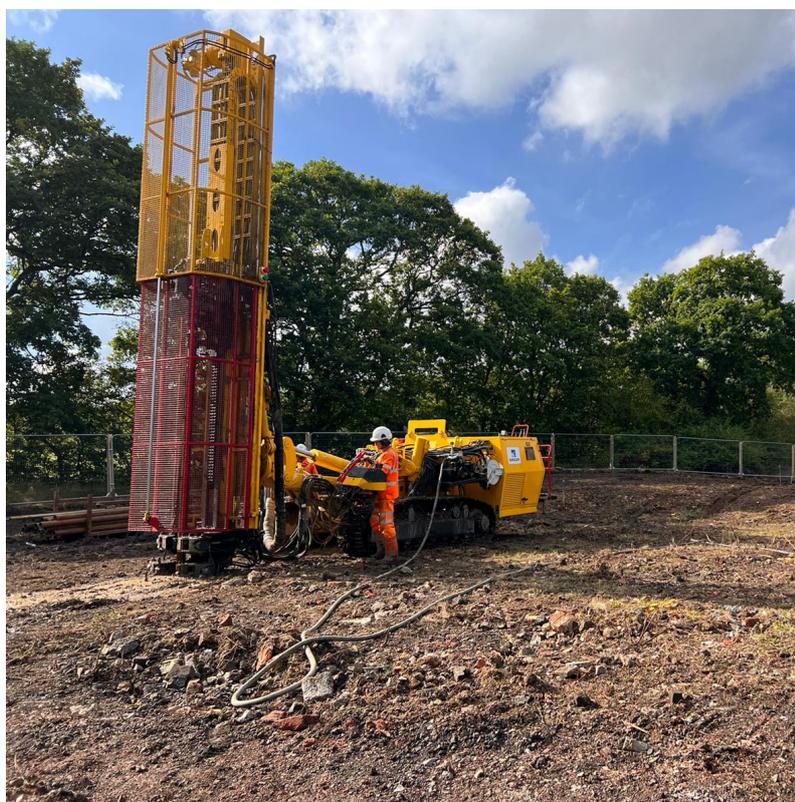
Drilling is highly dependable on production and how quickly you treat them. The drilling process involves rotary percussive rigs, firstly installing casing seated into rockhead, then drilling to 1m below the base of the seam. Commencing at the lowest dip side, grout is injected through a flexible tube called a tremie from the bottom of the drilling hole to the surface.
